## Image Report

Project: Hampden Mall Roof

Image: 0004\_IR8000

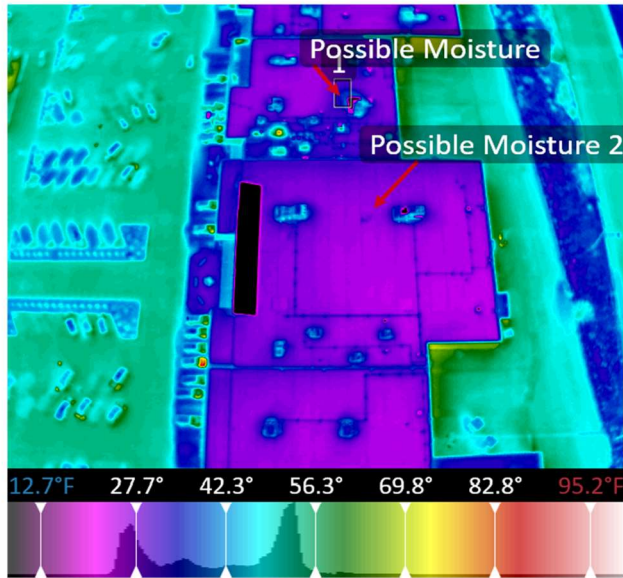
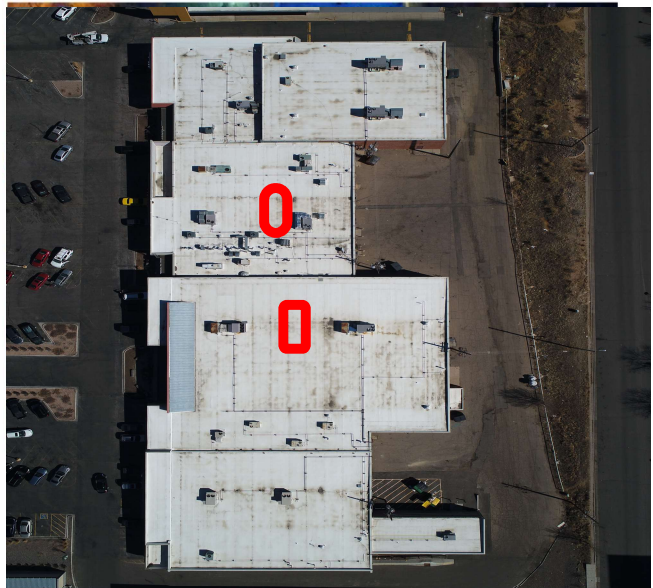
Annotation: Possible Moisture 2

Comment	Anomalies indicative of moisture retention under roof membrane.
Probable Cause	Ponding adjacent to seepage area.
Recommendation	Perform visual inspection using a moisture meter.

Annotation: Possible Moisture

Comment	Deveiation of Temperature around RTU Penetration
Probable Cause	Moisture/ Poor Roof Penetrtration Seal
Recommendation	Perfrom Visual on RTU and Surrounding and Surrounding Membrane.
