Image Report

Project: Hampden Mall Roof

Image: 0012_IR8000

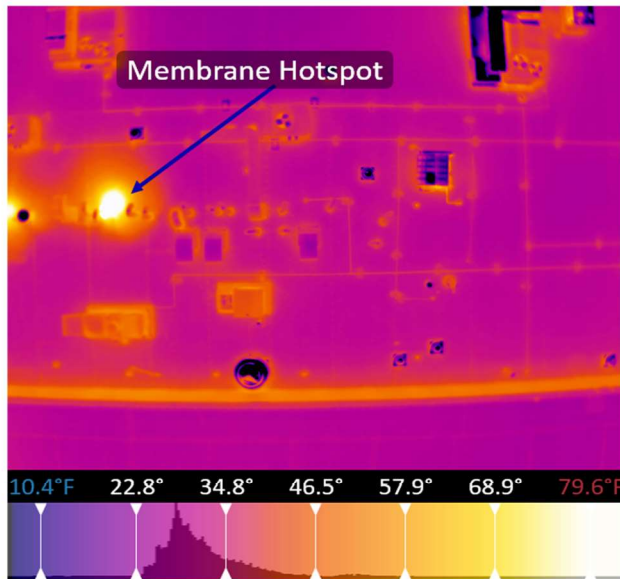
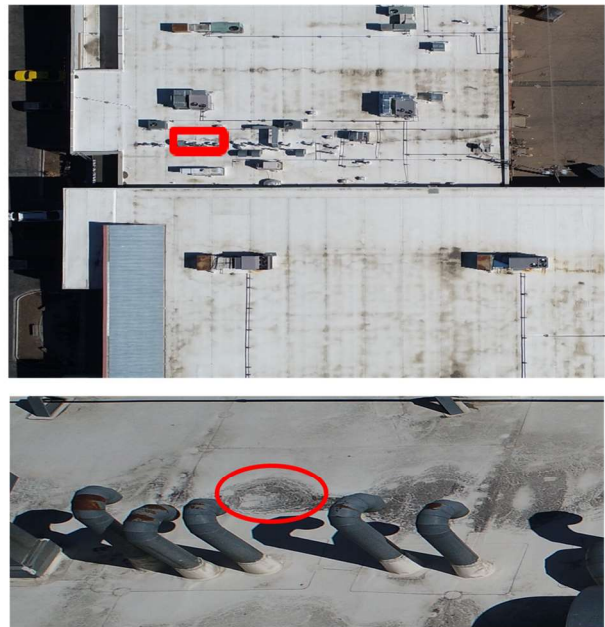
Annotation: Membrane Hotspot

Comment	Anomaly indicative of roof membrane degradation.
Probable Cause	Excessive exhaust heat.
Recommendation	Perform visual inspection on membrane.
